Manhole Inspection Summary

Manhole # S33A1_005MH

Location Address: **250 w dickman st**

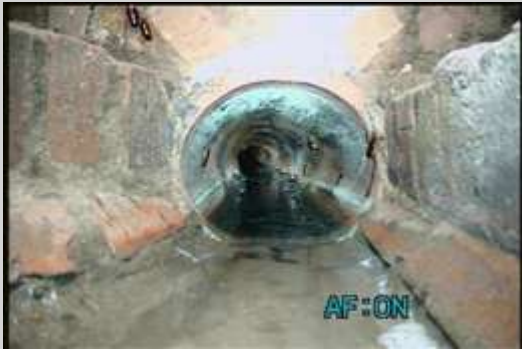
12 O'Clock Outflow

8 in. Circular Gravity Sewer
Pipe Out @ 12 O'Clock

Pipe Material: **Clay** ☐ Pipe Lined

Invert Depth: **6.50** (ft.) Flow Characteristics: **Fast**

Deposits: ☒ None ☐ Mud ☐ Sludge ☐ Debris ☐ Grease

Infiltration: **None** Pipe Seal Cond: **Unknown**

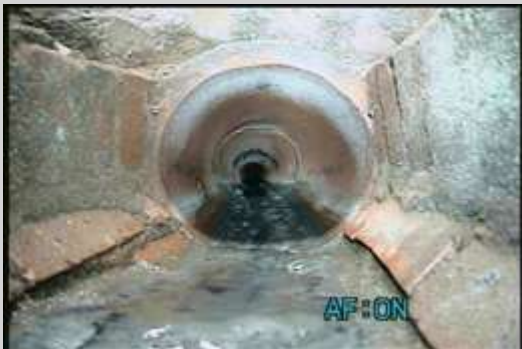
6 O'Clock Inflow

8 in. Circular Gravity Sewer
Pipe In @ 6 O'Clock

Pipe Material: **Clay** ☐ Pipe Lined

Invert Depth: **6.33** (ft.) Flow Characteristics: **Fast**

Deposits: ☒ None ☐ Mud ☐ Sludge ☐ Debris ☐ Grease

Infiltration: **None** Pipe Seal Cond: **Unknown**

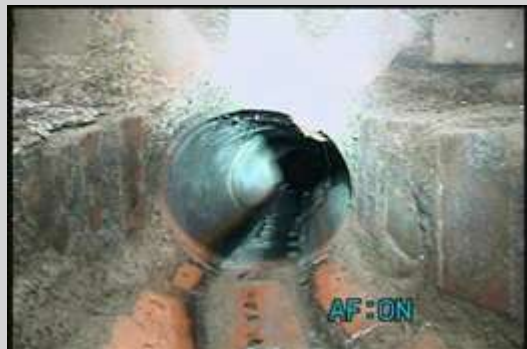
9 O'Clock Inflow

6 in. Circular Gravity Sewer
Pipe In @ 9 O'Clock

Pipe Material: **Clay** ☐ Pipe Lined

Infiltration: **None** Pipe Seal Cond: **Unknown**
